AMMRC-TR-82-43

FRACTURE ANALYSIS OF REACTION-BONDED SILICON NITRIDE TURBINE SHROUDS

JUNE 1982

**ARMY MATERIALS AND MECHANICS RESEARCH CENTER
Watertown, Massachusetts 02172**

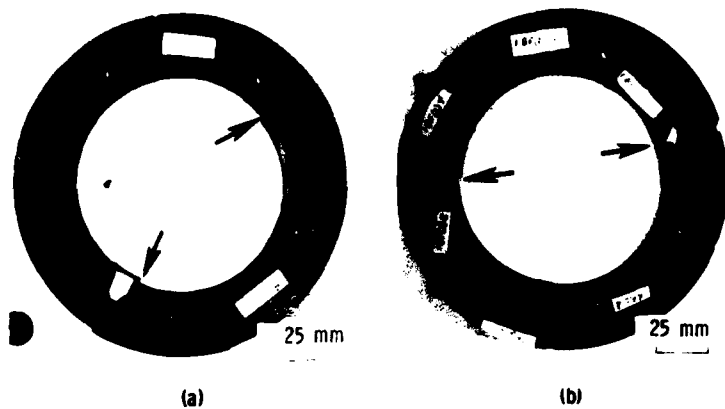
Figures 2 through 6 are photographs of the RBSN shrouds as they appeared after testing in the engine simulator rig. One shroud (1-Ar, Figure 2) survived intact with the remainder showing behavior ranging from subcritical cracking to catastrophic failure.

Figure 2. RBSN forward shrouds after testing in the 10-kW turbo alternator. (a) and (b) were tested in different runs. The arrows point to sites where fracture initiated.

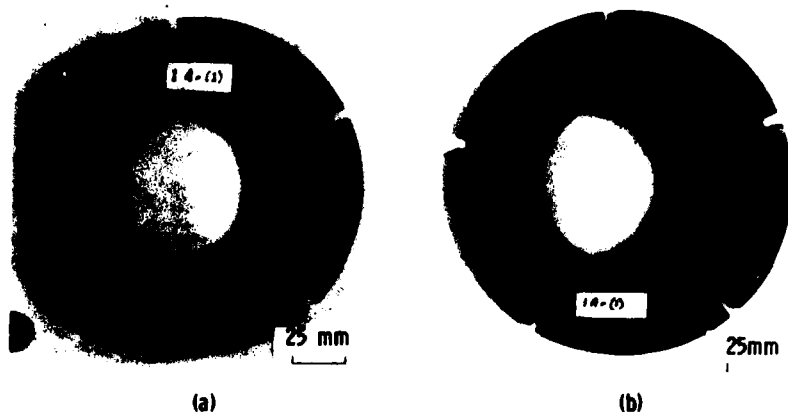
Figure 3. RBSN rear shroud after testing in the 10-kW turbo alternator with (a) front view and (b) rear view. This part was uncracked.

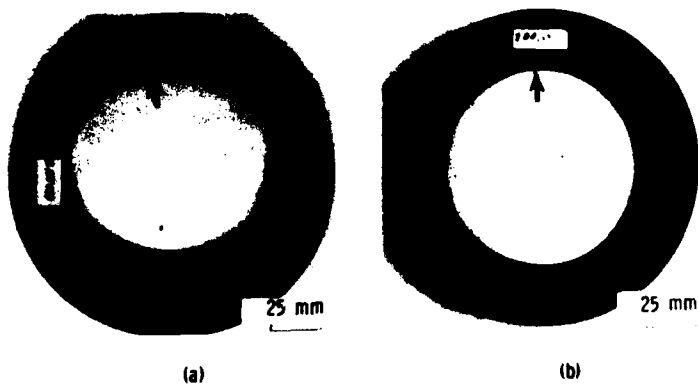
Figure 5. RBSN forward shroud from 10-kW turbo alternator after testing with (a) front view and (b) rear view. Arrow points to location of subcritical crack.

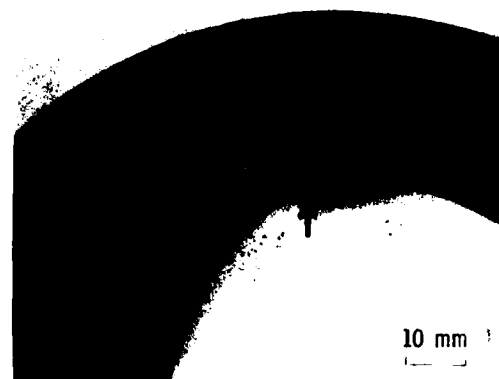
Figure 6. Detail of subcritical crack in forward shroud 1-Df. The crack was defined by tracing it with a felt-tip pen.

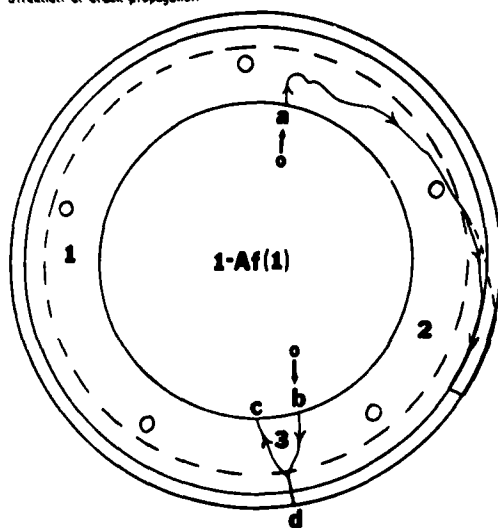
In the example shown in Figure 9, the second crack may have originated at a large defect, rather than at the maximum stress location, or failure could have originated simultaneously at locations "a" and "c". The latter seems more plausible since the subcritical crack at "d" is diametrically opposite a point midway between "a" and "c". It is impossible to deduce unequivocally from the fracture patterns in Figures 7 through 9 which fracture occurred first. For the case in which failure was catastrophic, however, it appears that the first crack initiated at "a" (Figure 8). That crack has more branches than the one starting at "e", suggesting that the stress was higher at "a",⁵ and the branch traveling circumferentially counterclockwise traveled much further than the intersecting crack from location "e". The crack starting at "e" may also have traveled slightly farther before branching, again indicating that the failure stress may have been lower at that point.⁶ It may also be noted that the catastrophic cracking in shroud 1-Bf (2) (Figure 8) indicates that it failed at a higher stress level than the other two (Figures 7 and 9).

Figure 7. Fracture patterns in RBSN forward shroud after testing. The arrows labeled "o" indicate sites where fracture initiated.

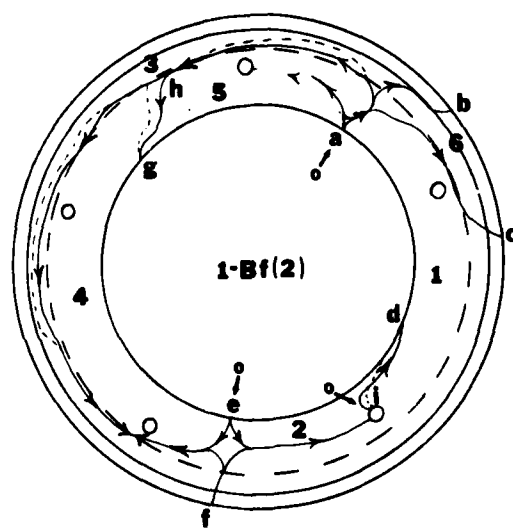
shroud with the exception of one case, shroud 1-Bf (2) (Figure 8), where an origin was found at a bolt hole.

Figure 8. Fracture patterns in RBSN forward shroud after testing. The arrows labeled "o" indicate sites where fracture initiated. Note area near hole (lower left) where circumferential cracks meet.

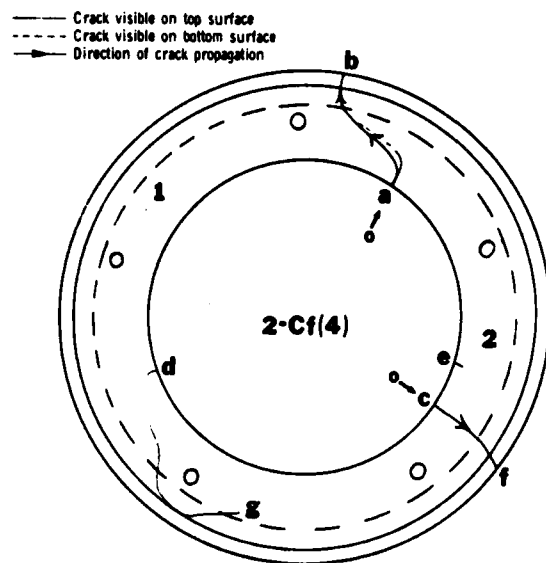
Figure 9. Fracture patterns in RBSN forward shroud after testing. The arrows labeled "o" indicate sites where fracture initiated. The line d-g indicates a subcritical crack.

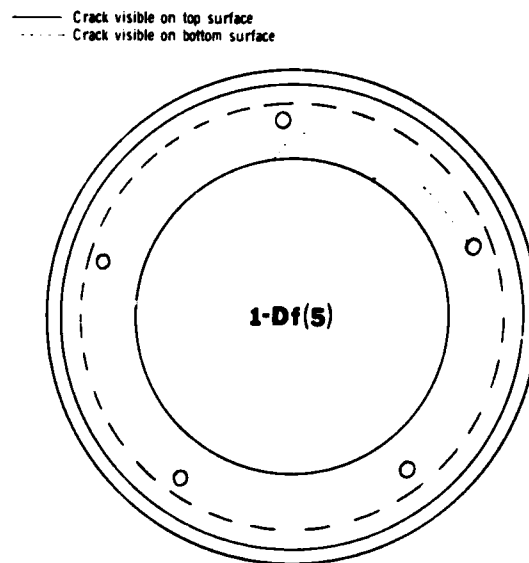
Figure 10. Fracture patterns in RBSN forward shroud after testing. The cracks shown are subcritical.

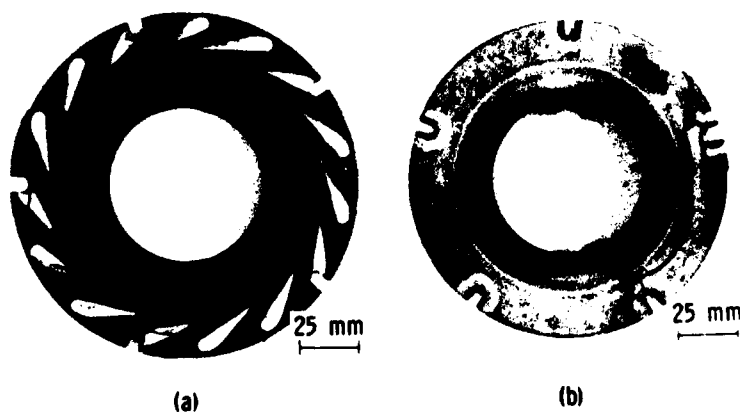
Shroud 4-Er (7), which failed during engine rig testing, is shown in Figures 11 and 12. During testing of that shroud, combustion problems occurred which were attributed to compressor surge.¹ When the rig was disassembled for examination after 33 hours, the crack "g-h" (Figure 12) was discovered. Piece No. 5 remained in place, however, and testing was continued. After 50 hours, the exhaust scroll was found to be partially collapsed, the additional cracking in the rear shroud (Figure 12) was observed, and the test was terminated. The cause of failure at that point was believed to be excessive stress generated by buckling of the exhaust scroll.

Figure 11. RBSN rear shroud after 50 hours of testing in the 10-kW turbo alternator with (a) front view and (b) rear view. Arrows indicate regions where fracture originated.

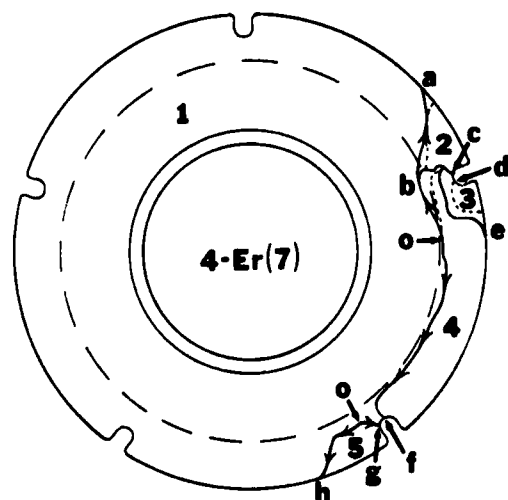
The fracture behavior of shroud 4-Er (7) which endured 50 hours of engine rig testing was markedly different than that described above. Crack initiation sites (if any) and propagation directions in the vicinity of locations "c" and "d" in Figure 12 were impossible to establish with certainty. The two identifiable fracture origins both appeared to be internal ones. It is likely that those failures resulted from thermal stress during heating; such a situation would induce compressive stresses on the outside, and corresponding corresponding tensile stresses on the inside of the part.

Figure 12. Fracture patterns in RBSN rear shroud after 50 hours of testing. The arrows labeled "o" indicate sites where fracture originated. Crack g-h was present after 33 hours of testing.

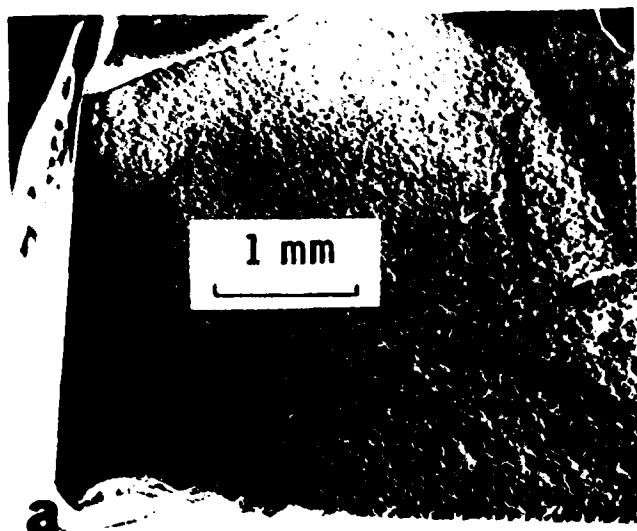
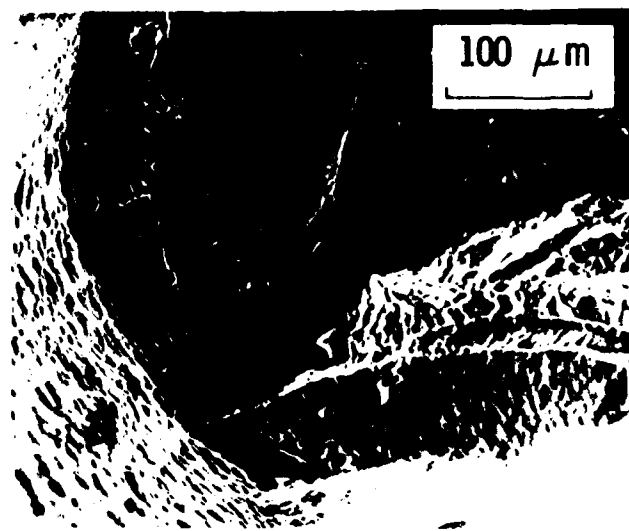
The fracture surfaces shown in Figure 13a and b exhibit the classical features found on such surfaces,^{3,4} i.e., a smooth "mirror" region near the origin (point "a" in Figure 13b), a coarser "mist" region beyond the mirror, and the coarse "hackle" region beyond the mist. These features are particularly well-defined in Figure 16a, and the corresponding regions labeled for reference. Note that the "river" patterns in the hackle region may be traced back to the fracture origin which, as already mentioned, is at an inside corner of the shroud. Figure 14 shows another part of shroud 1-Af (1); the hackle lines at the left indicate that the crack emerged (rather than initiated) at that location.

The calculated fracture stress values in Table 5 agree well with the results in Table 2 for bend specimens tested with as-received surfaces. In the case of the shrouds, Figures 13, 15, 17, 21, and 23 show evidence of gross machining defects near fracture origins. Similar defects were suspected, but not observed clearly at fracture origins in bend bars with as-received surfaces. On the other hand, it has already been noted that numerous failures in bend specimens with machined surfaces were related to machining flaws (less severe than the above-mentioned ones), but statistical testing results were inconclusive as to whether or not such relatively minor flaws significantly lowered strength. Jones and Rowcliffe¹⁹ similarly noted that their RBSN specimens frequently had machining grooves at fracture origins. In view of the foregoing discussion it appears that, at some level, the fracture strength of RBSN will be significantly degraded by the presence of surface machining flaws.

Figure 13. Fracture surfaces near fracture origin "a" in shroud 1-Af (1). (a) and (b) are photomicrographs of matching fracture surfaces; (c) and (d) are scanning electron photomicrographs of surface shown in (b). The prominent surface features in (d) are believed to be cracks emanating from the machining striae evident on the surface (lower left).

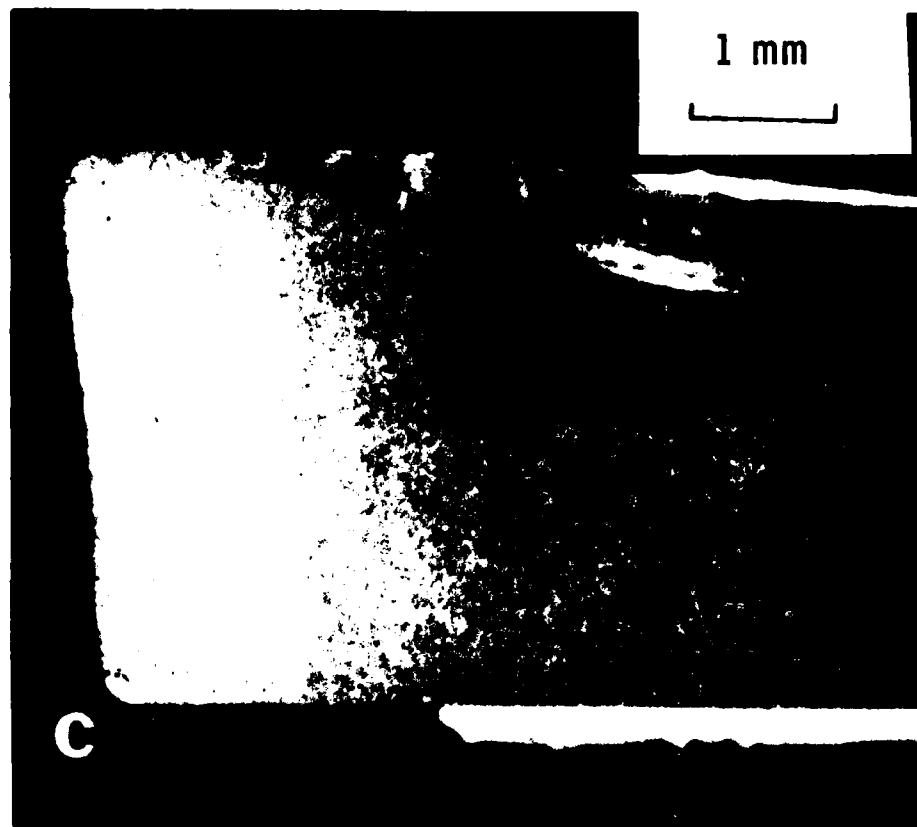
1-Af (1) c3

Figure 14. Photomicrograph of fracture surface near "c" in shroud 1-Af (1). Hackle lines visible at left indicate that the crack emerged in that area.

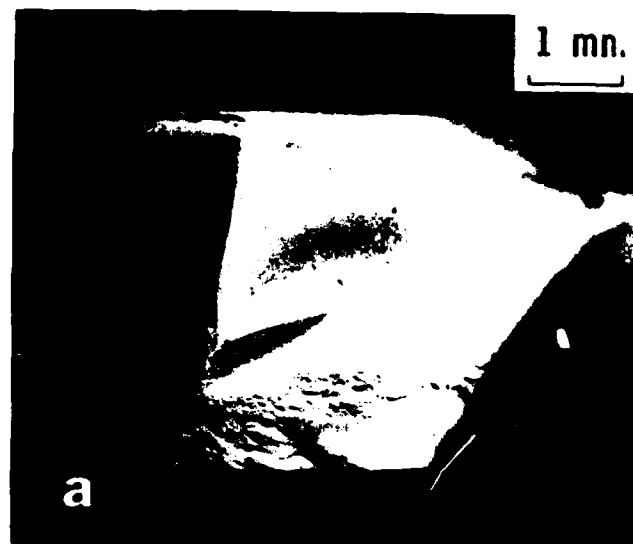
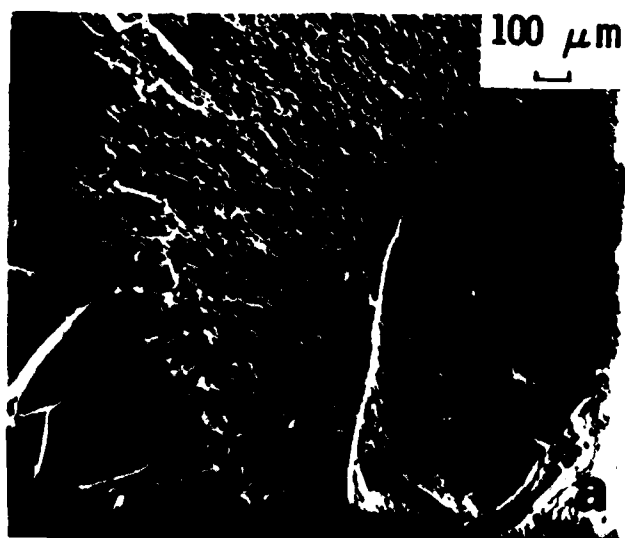
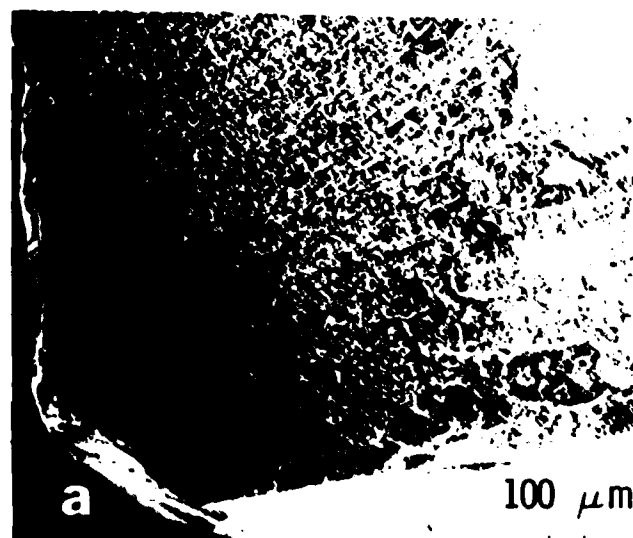
Figures 15 through 19 show various features of the fracture of shroud 1-Bf (2). Figure 15 illustrates one problem in post-mortem fracture analysis; the chip in the lower corner in (a) is not duplicated in (b) suggesting that it occurred in handling after the fracture event. The markings in Figures 15 through 19 again indicate that fracture initiated at inside corners. The large hackle marks in Figure 16 suggest catastrophic failure and Figure 17 shows a large pore near the fracture origin. Also present in the same region are large surface gouges that are probably left over from machining of the component. Figures 18 and 19 show surfaces near the origin of the only fracture that started at a hole. Prominent in Figure 18 are Wallner lines, the semicircular markings some distance away from location "i". These features are always concave toward the fracture origin.^{3,4} Figure 19 shows a possible chip or machining defect (near "i") at which fracture could have originated.

Figure 15. Fracture surfaces near fracture origin "a" in shroud 1-Bf (2). (a) and (b) are photomicrographs of matching fracture surfaces; (c) and (d) are scanning electron photomicrographs of the same surfaces. The chip evident in the lower right of (a) and (c) probably occurred in handling.

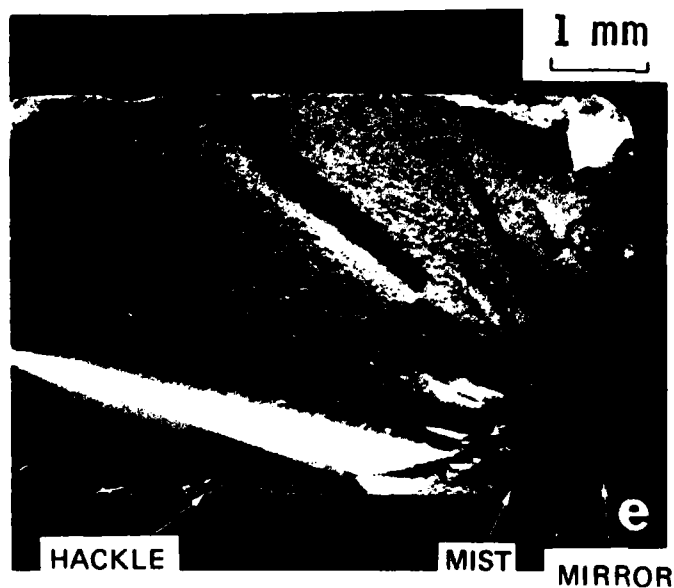
Figure 16. (a) and (b) are photomicrographs of matching fracture surfaces near fracture origin "e" in shroud 1-Bf (2). (c) and (d) are scanning electron photomicrographs showing appearances of surface respectively close to and away from the fracture origin.

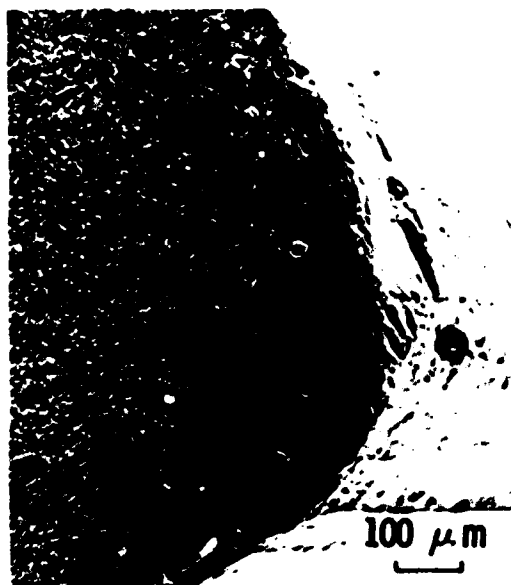
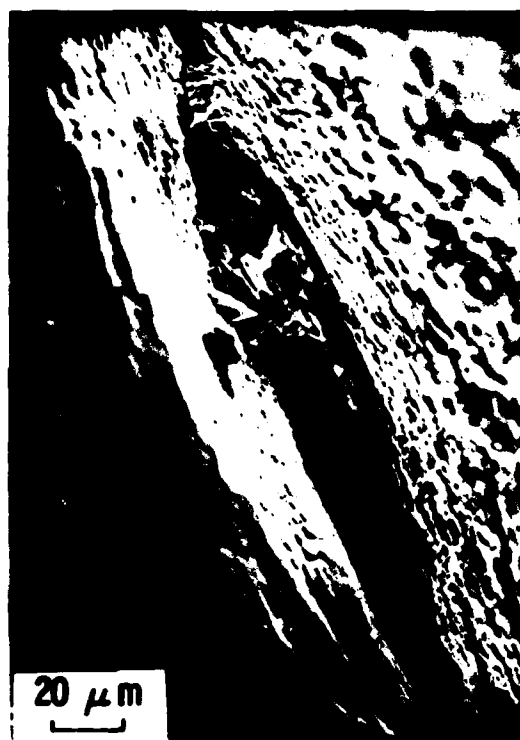
Figure 17. Scanning electron photomicrographs of fracture surfaces near fracture origin "e" in shroud 1-Bf (2). Visible in (a) and (b) are machining striae and a chip near "e". The probable fracture origin, a large pore, is visible in (c) and (d). The white area in (d) are probably dust.

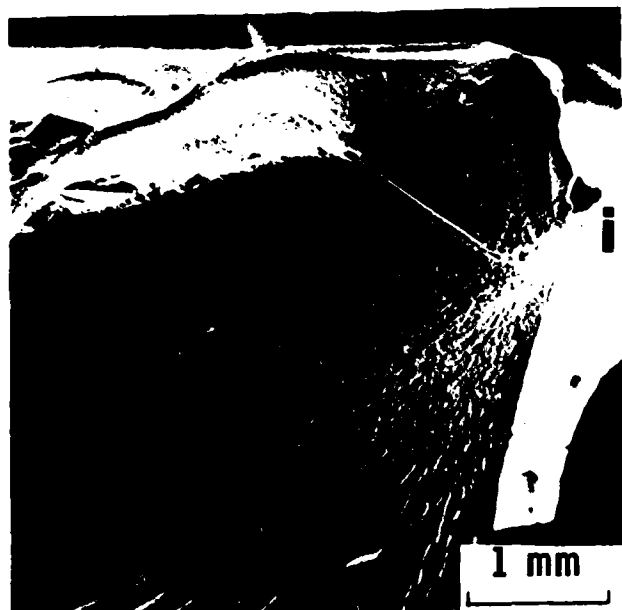
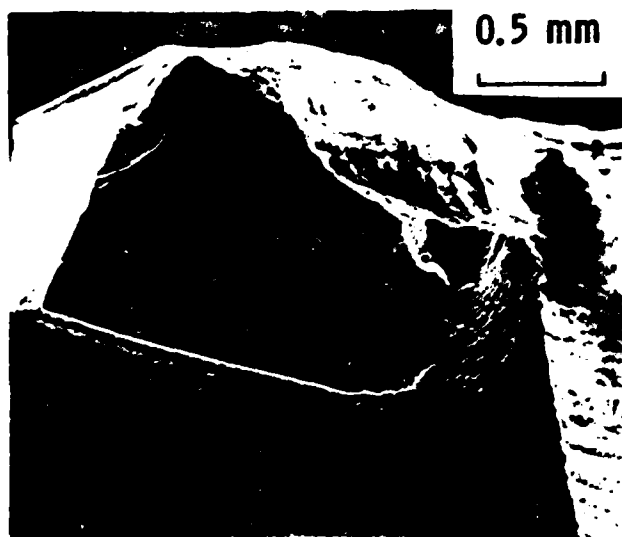
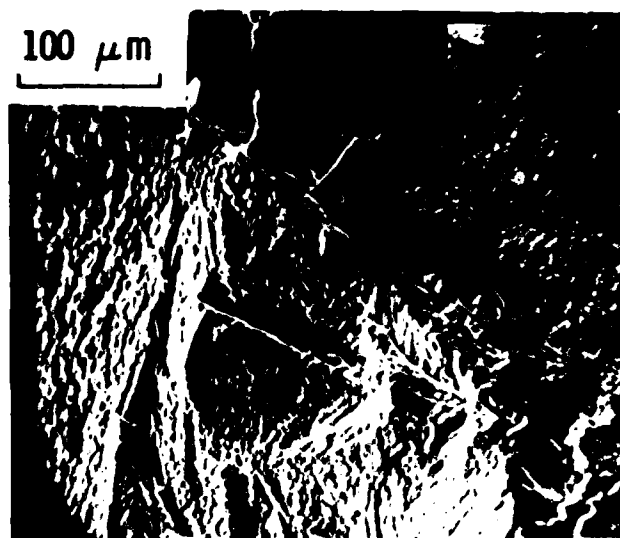
Figure 19. Scanning electron photomicrographs of fracture surfaces near fracture origin "i" in shroud 1-Bf (2).

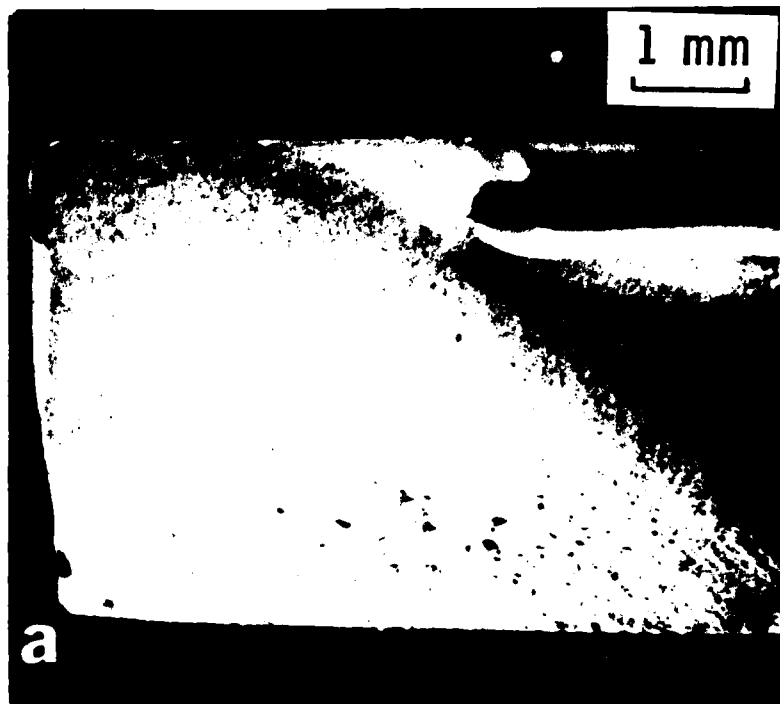
Figures 20 through 24 show fracture surfaces on shroud 2-Cf (4). The chip near the lower left corner in Figure 20b probably occurred during handling, and fracture again initiated at the inside corner. Evident in Figure 21 is a large gouge on the edge of the component near the fracture origin as well as a large inclusion in the same region. Fracture surfaces near origin "c" are shown in Figure 22 and 23. The groove on the corner near "c" (Figure 23) may have caused failure. The region near "d" in which a subcritical crack originated is shown in Figure 24. Note the especially small fracture mirror associated with this origin. Figure 25 shows clearly the type of large machining striations that were found in several instances.

Figure 20. Photomicrographs of matching fracture surfaces near fracture origin "a" in shroud 2-Cf (4).

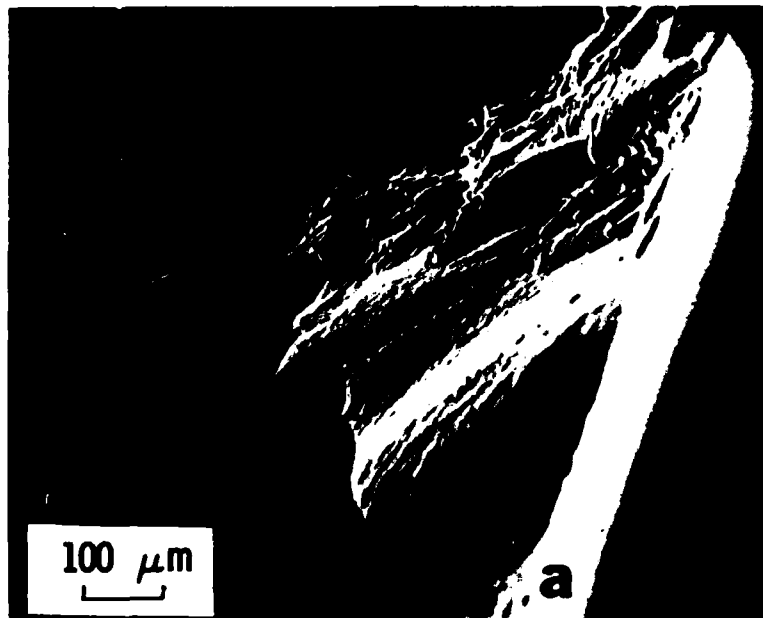
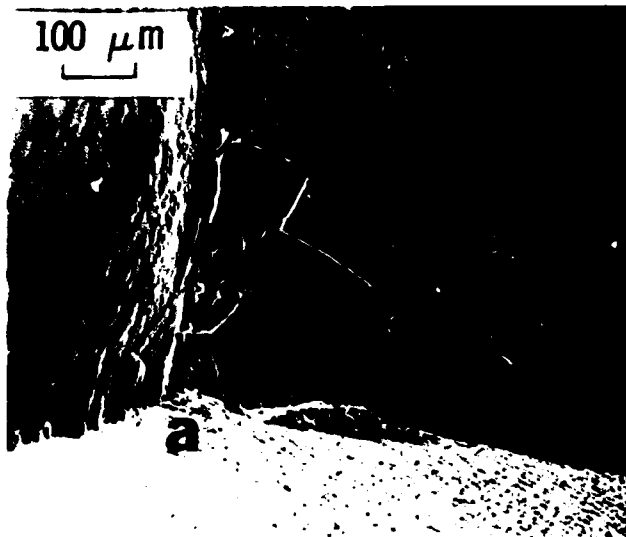
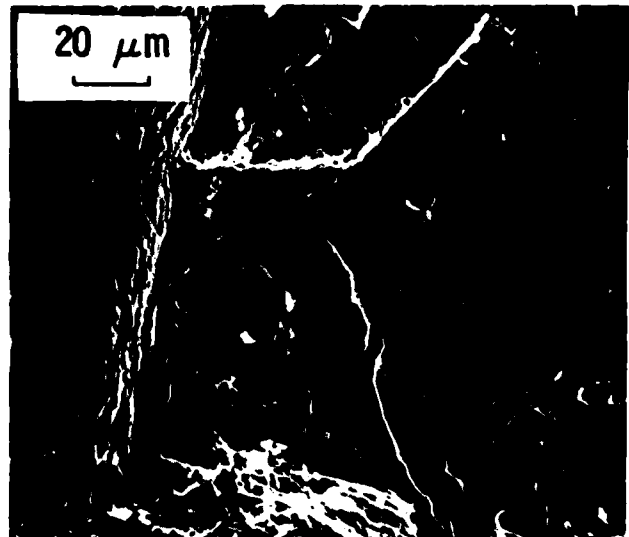
Figure 21. Scanning electron photomicrographs of fracture surfaces near fracture origin "a" in shroud 2-Cf (4). The probable fracture origin is the large inclusion evident near the center of (c).

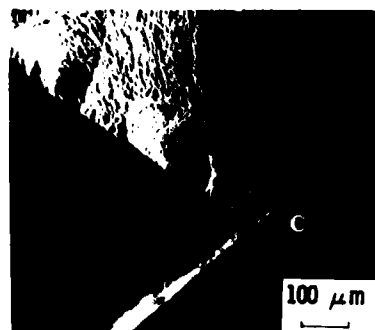
Figure 23. Scanning electron photomicrographs of fracture surfaces near fracture origin "c" in shroud 2-Cf (4).

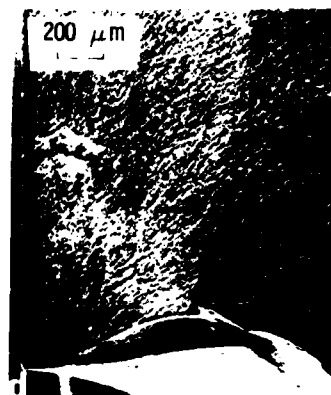
Figure 24. Fracture surfaces near "d" in shroud 2-Cf (4). (a) is a photomicrograph and (b) is a scanning electron photomicrograph.
